REPORT AND RECOMMENDATIONS ON UNDERWATER DAMAGE

REPORT & RECOMMENDATIONS  
ON UNDERWATER DAMAGE ASSESSMENT  
PIER LIMA  
NAVAL STATION, GUANTANAMO BAY, CUBA

Report & Recommendations on Underwater Damage Assessment Pier Lima Naval  
Station, Guantanamo Bay, Cuba

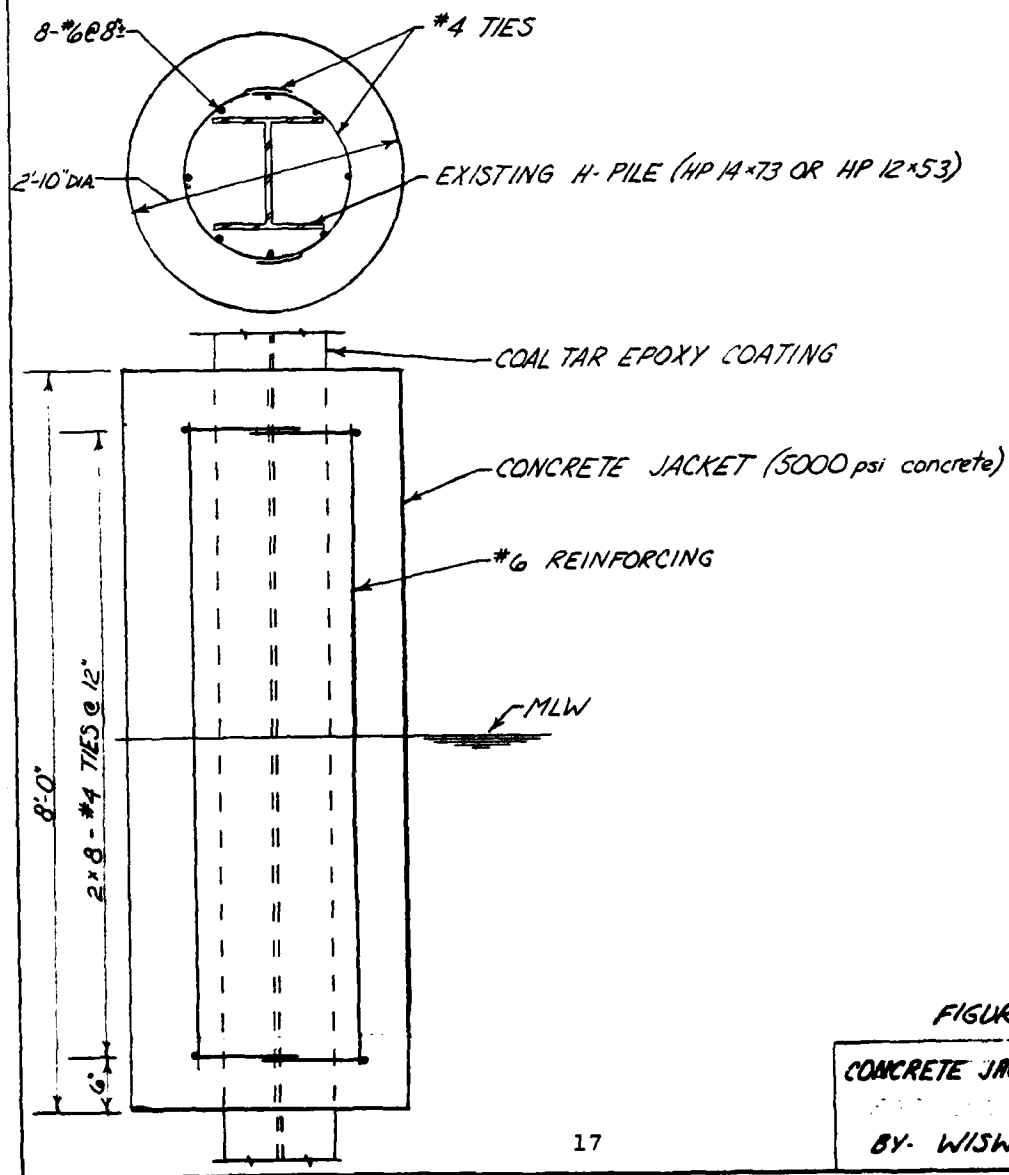
FIGURE 1

CONCRETE JACKET DESIGN  
BY WISWELL, INC.

1. PILE JACKETS All of the small older-style jackets should be removed and replaced. In most cases these jackets are presently cracked in the area of each flange, making removal not difficult. Due to the uncertain concrete strength, numerous cracks and spalling occur both above and below the waterline, so the jackets do not effectively add strength to the piles. If these jackets were left on, they would continue to deteriorate and offer less and less structural strength.  
The pile jackets that replace these should be longer jackets, approximately 8 feet long, to encompass all of the heavy deterioration of the piles. These jackets should contain a reinforcing bar cage as shown in the attached engineering drawing and should be of proper 5000 psi concrete. After installation of the pile jacket, the exposed steel pile between the pile cap and the new pile jacket should be sandblasted to commercial finish and a coal tar epoxy applied.
